A Systematic Evaluation of Barrier Free Adaptations in Historic Buildings - The Case of the Main Building at the TU Wien

A Master's Thesis submitted for the degree of
"Master of Science"

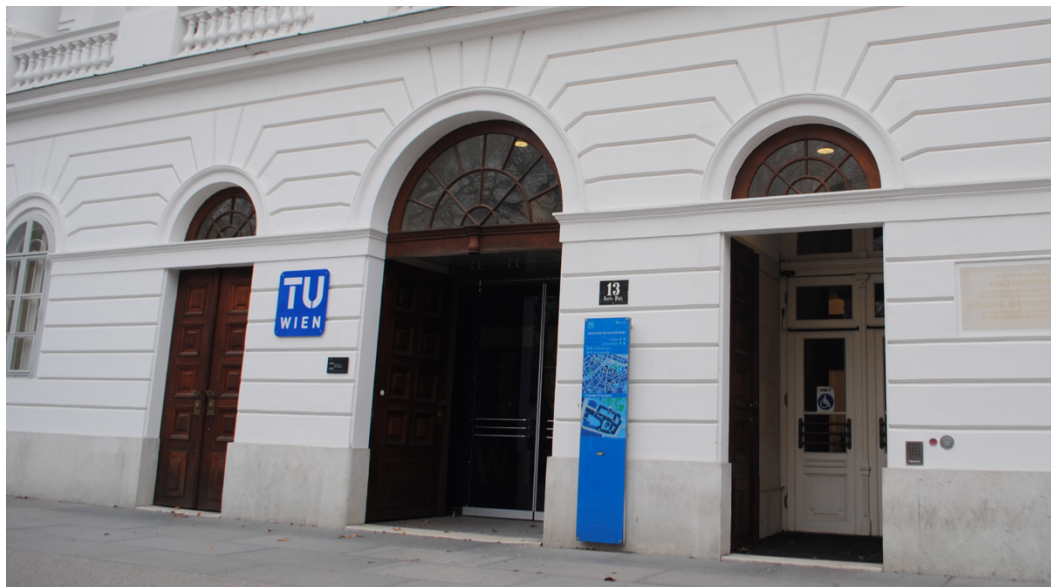
Figure 5-1 Main entrance of the TUW - ES1

Three wooden double gates constitute the principal entrance (ES1) of the TUW's main building located in Karlsplatz 13 (see Figure 5-1). To provide access to all visitors of the university, two of these doors remain open during all times of operation. An additional set of doors is positioned immediately beyond the exterior entryways. The central doors are double leaf glass. On the west side, these are automated wooden double doors for disability use only.

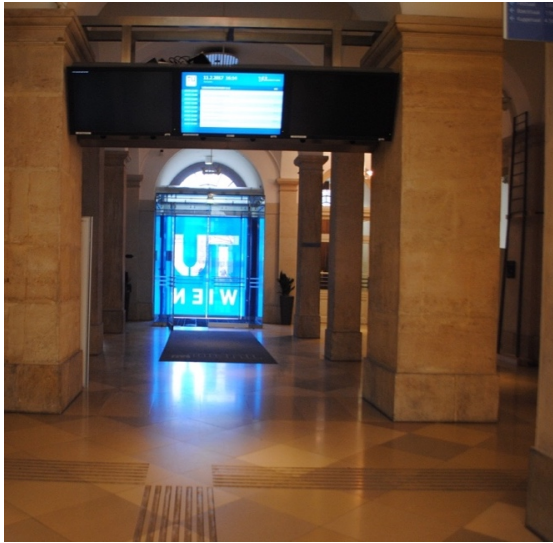
Figure 5-2 View of the main hall

The entrance grants access to a three-aisle main hall on the ground floor divided by Tuscan columns. This hall serves as a transitional space, leading to a main staircase, an elevator, the eastern corridor on the ground floor and the first inner courtyard. The main hall is equipped with benches, a cloakroom, an information point with personnel assistance and a computer information station. From the automated doors, there are tactile ground surface indicators, providing guidance to the aforementioned facilities. Figure 5-2 shows the view from the main hall.

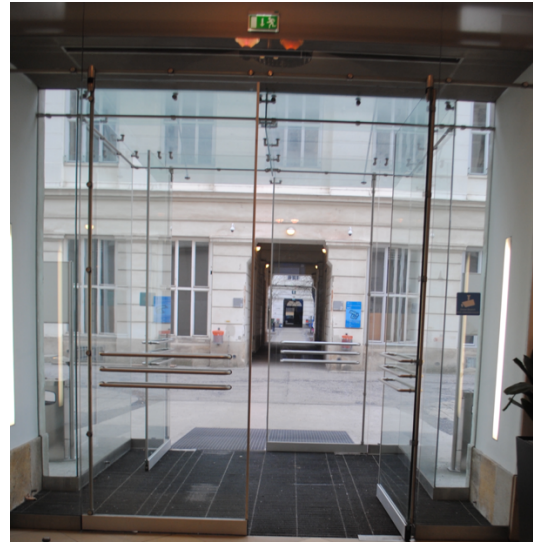
Figure 5-3 Entrance from the first courtyard – EH1

in Figure 5-3. This first inner courtyard also connects to the other sections of the building.

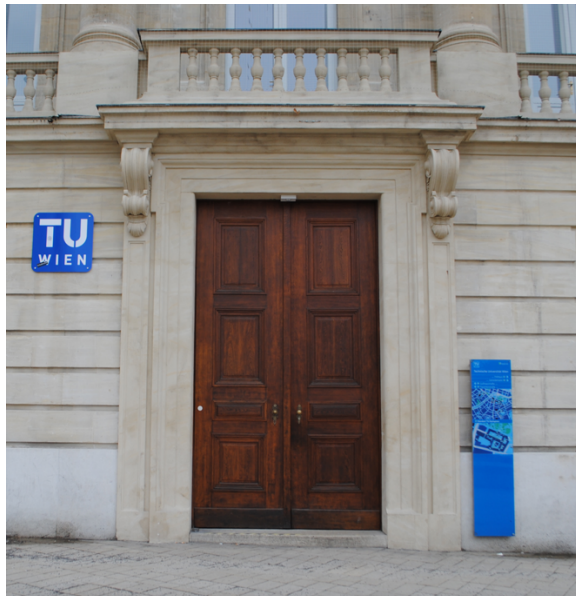
Figure 5-4 Second main entrance on the Karlsgasse – ES2

The second main entrance of the building is on the Karlsgasse, facing the St. Charles's Church on the northeast side of the building (ES2). The entry is a massive historic wooden double door of six panels and a single-step rise, as can be seen in Figure 5-4. A second additional set of wooden doors with glass panels is inside the building, immediately beyond the main external gate (see Figure 5-5).

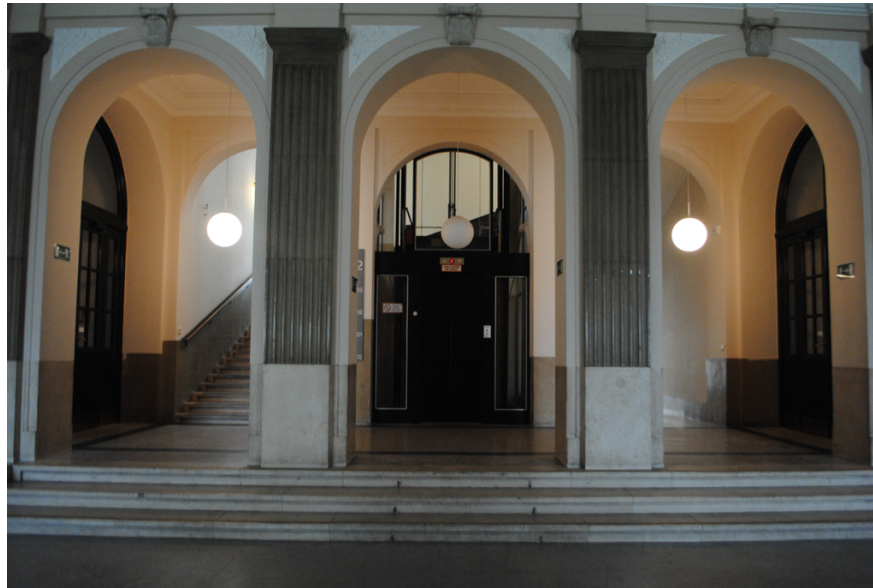
Figure 5-6 Second main hall

steps at the center of the hall. The second hall also serves as a transitional space between the eastern corridor of the building's first staircase and the AE edifice via stairs and a second elevator. Figure 5-6 shows the second hall from the entrance.

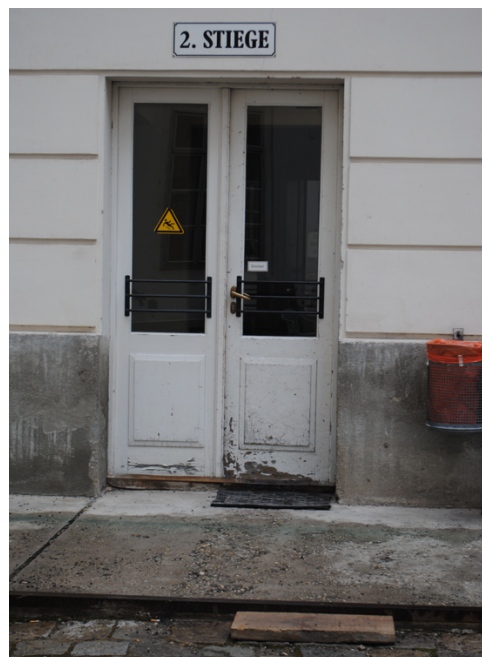
Figure 5-7 Entrance from the third inner courtyard - EH3a

There is an entrance (EH3a) of wooden double doors with glass panels and narrow leaves from the third inner courtyard in the area behind the second main staircase and the elevator (see Figure 5-7). From the outside, a step rises to the door, whereas on the inside, five steps are provided past the building's entrance.

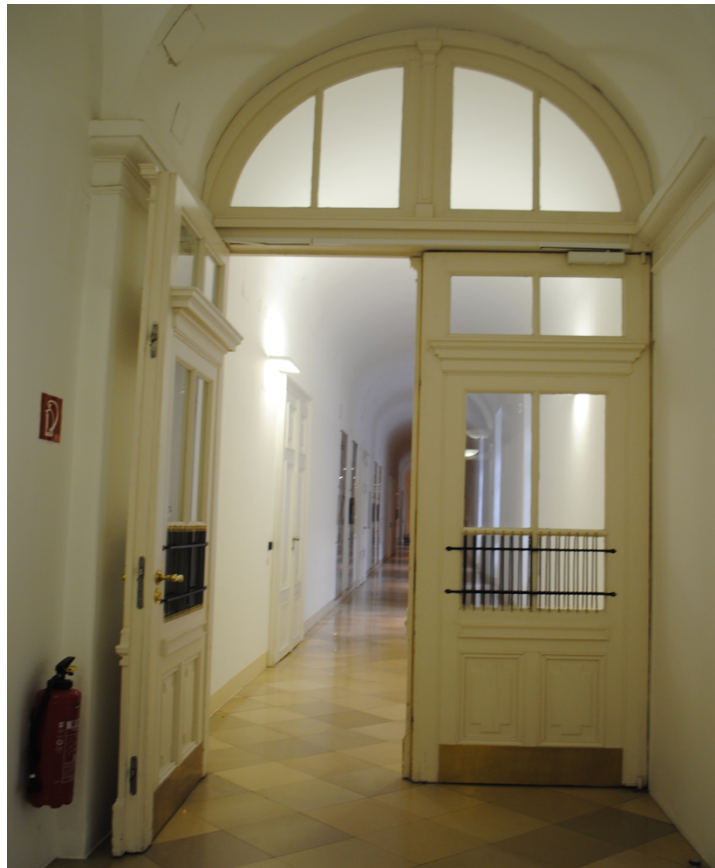
Figure 5-8 Corridor doors as on the first and second levels, open during operating time.

Identical wooden double doors with arched fanlights (D1S1a, D1S1b, D2S1a, D2S1b) are located opposite each other providing a passageway to corridors on the first and second levels (see Figure 5-8). These approaches function as entrances from the middle corridor to the eastern and western corridors, circumscribing the area in front of main staircase 1. During operating times, one section of the doors remains open to facilitate access.

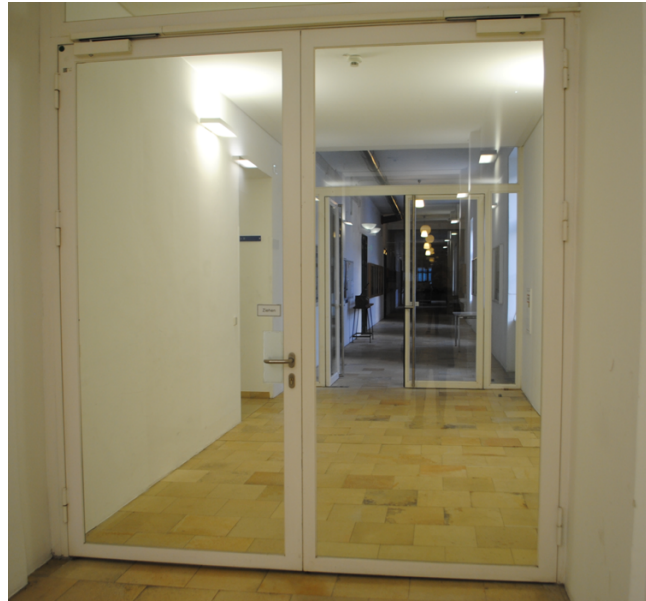
Figure 5-9 Corridor doors as on the third level

On the third level, in both corridors, a similar configuration is provided with two consecutive sets of glass double doors. The outer set of doors (D3S1a, D3S1b) encloses the middle corridor at the base of the main staircase, and the inner doors (D3S1d, D3S1e) separate the eastern and western corridors from auxiliary staircases 1a and 1b, respectively. An example of the door arrangement for the corridors on the third level is presented in Figure 5-9.

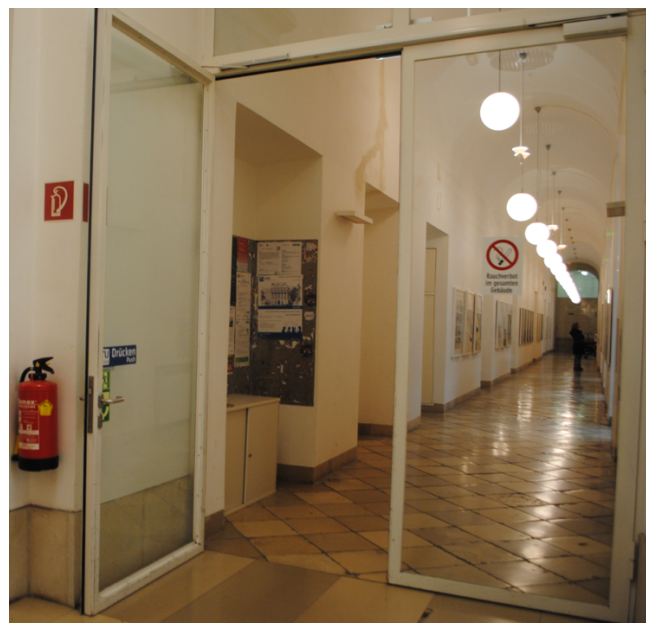
Figure 5-10 Glass door granting access to the eastern corridor on the ground level - D0S1a

Access to the eastern corridor from the main hall on the ground floor, is through glass doors (D0S1a) which remain open during operating times. (see Figure 5-10). Similarly, on the top floor, a glass pane provides passage between the auditorium in the dome and the eastern corridor (D4S1a).

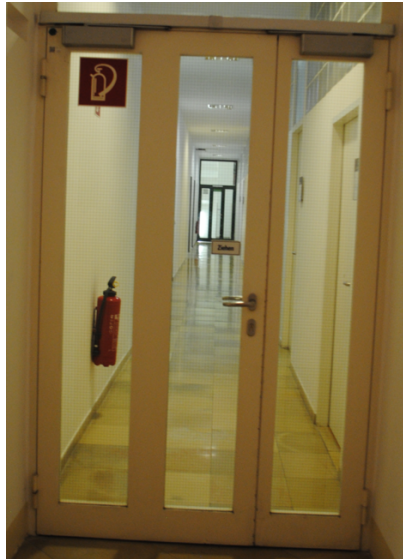
Figure 5-11 Doors connecting the eastern corridor to the AB section on the first two levels.

The eastern corridors from the first to the fourth story, connect with the AB section of the building through a set of glass double doors on each floor (D1S1c, D2S1c, D3S1c, D4S1c), as shown in Figure 5-11 and Figure 5-12. In the western corridor of the first floor, two additional wooden double doors (D1S1d, D1S1e), divide the corridor centrally, leading to the sanitary facilities in the AD section of the building.

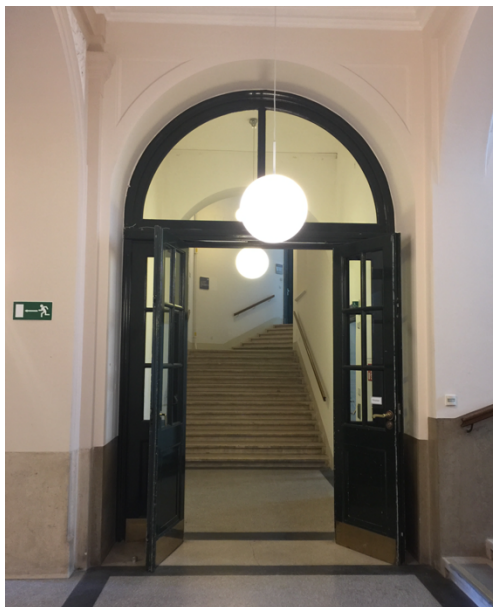
Figure 5-13 Corridor doors on the ground floor in the area of staircase 2

In the area of the second staircase, from the ground floor to the third level, identical wooden double doors with an arched fanlight and narrow openings (D0S2a, D0S2b, D1S2a, D1S2b, D2S2a, D2S2b, D3S2a, D3S2b) serve as entrance to two corridors. One of the doors leads to the eastern corridor of staircase 1 of the same area while the other one goes towards section AE. On the ground floor, both doors remain open during operating times. In the upper levels, only one narrow section of the door remains open, while the other part must be opened manually. Figure 5-13 and Figure 5-14 show the door configurations on the different levels.

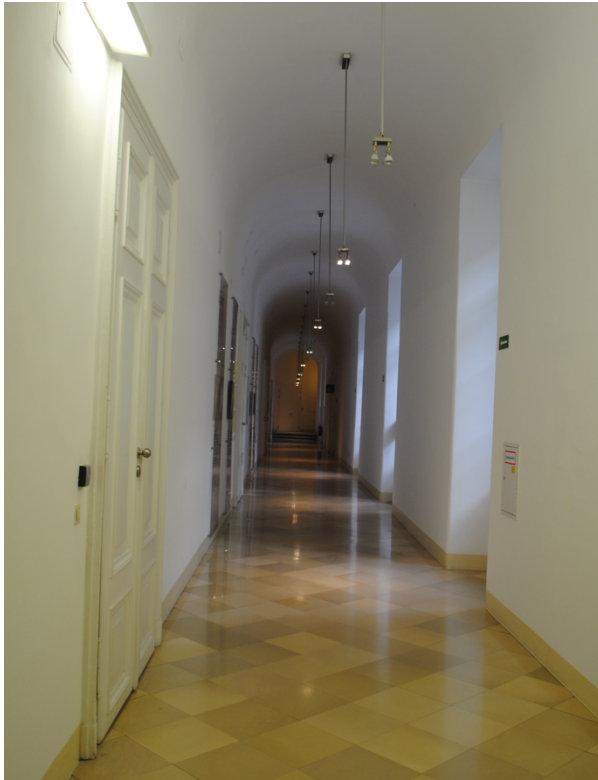
Figure 5-17 Eastern corridors in the area of staircase 1

There are eastern corridors on all floors of the main section that belong to the staircase 1 area (C0S1a, C1S1a, C2S1a, C3S1a, C4S1a). At the end of each of these corridors, the path turns south, allowing transition to staircase 2 of the same section. Several floors have level differences at this junction. Equalization of levels is achieved through stairs on the ground floor, two steps on the first floor, and a single step plus a ramp on the third floor. The facilities located along these passageways include different administrative offices, lecture halls, auditoriums and sanitary facilities. A crossing hall leading to the AB section can also be reached from the eastern corridors on all levels except the ground floor. An example of an eastern corridor is shown in Figure 5-17.

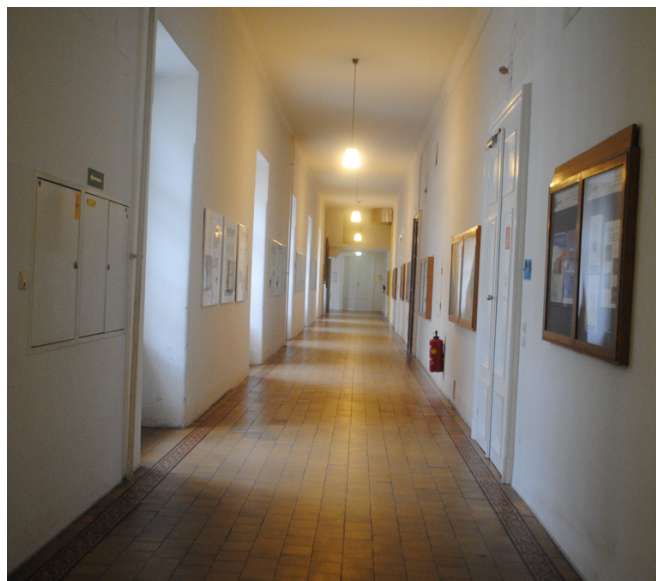
Figure 5-18 Western corridor in the area of staircase 1

On the opposite side, the western corridors (C1S1b, C2S1b, C3S1b) are located on levels one to three. These corridors provide passage mostly to administrative and office facilities, as can be seen in Figure 5-18. The AD tract is accessible from the western corridors located on the first and second stories. Three auxiliary staircases are positioned in the third-floor corridors to grant access to the fourth level.

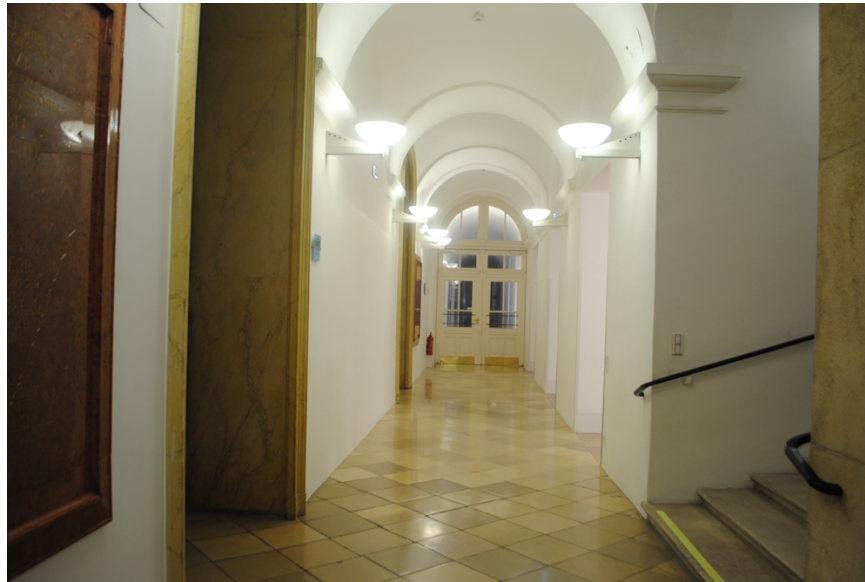
Figure 5-19 Middle corridor in the area of staircase 1

The middle tract of the corridors (C1S1, C2S1, C3S1) serve as a transitional space between horizontal and vertical access points (see Figure 5-19). These corridors allow the circulation between the staircase, elevator, eastern and western corridors, as well as other facilities such as foyers, offices and ceremonial halls, including the renowned “Festsaal” located on the first level.

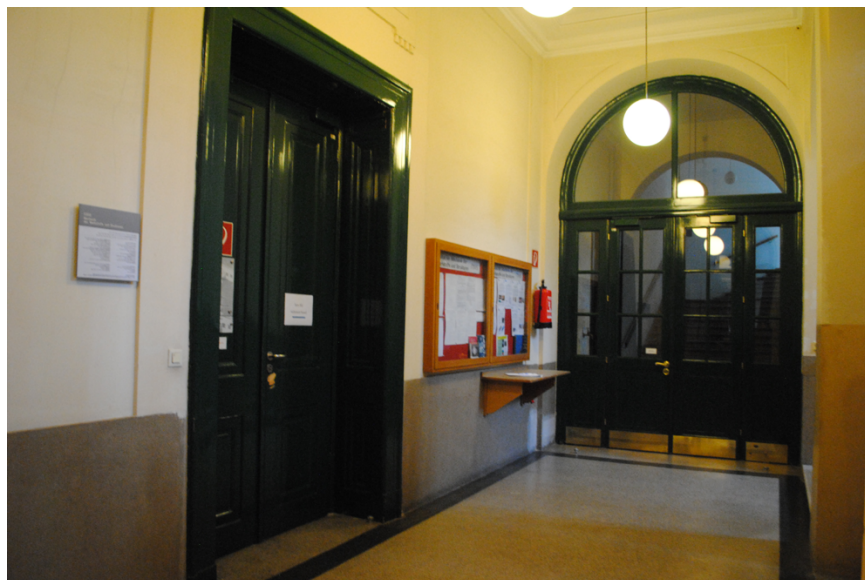
Figure 5-20 Corridors in the area of staircase 2

The corridors in front of staircase 2 and between the AA and the AE tracts of the building offer access to offices and administrative facilities on the first to the third floors (C1S2, C2S2, C3S2). A view of the corridors from the second staircase is represented in Figure 5-20.

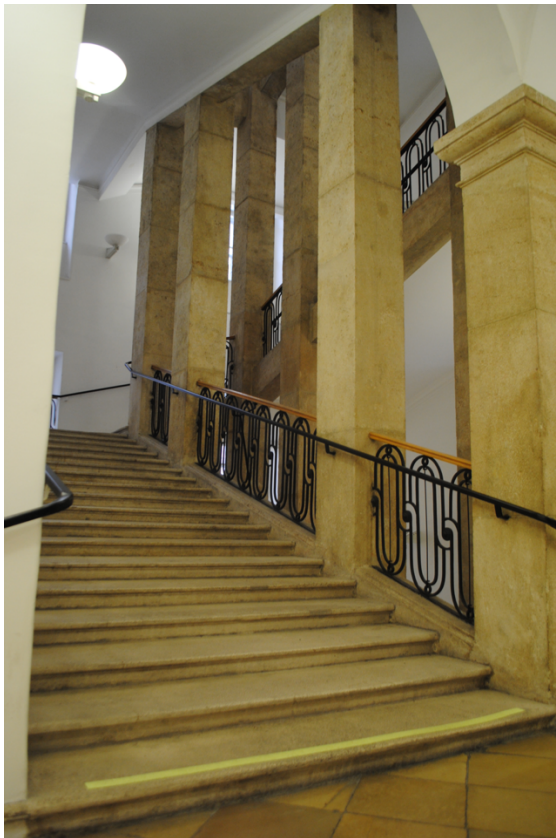
Figure 5-21 Main staircase 1 - S1

A u-shaped straight staircase with double landings (S1) constitutes one of the main staircases of the edifice and the principal staircase of the entire building (see Figure 5-21). Two rows of four pillars each with massive urn finials and allegorical figures, support the outstanding neoclassical structure, as shown in Figure 5-22. The staircase provides continuous access from the ground floor to the third floor. It has been enhanced with a continuous handrail that follows the total length of the stairs and with optical marking stripes in a contrasting color on all first and last steps.

the scoring of the first staircase is 67%. On the other hand, staircase 2 does not comply with the handrail requirements of height and continuity, with only one handrail in selected sections. It has optical markings on all first and last steps, but some of these have faded and need replacement. It therefore has received a scoring of only 56%.

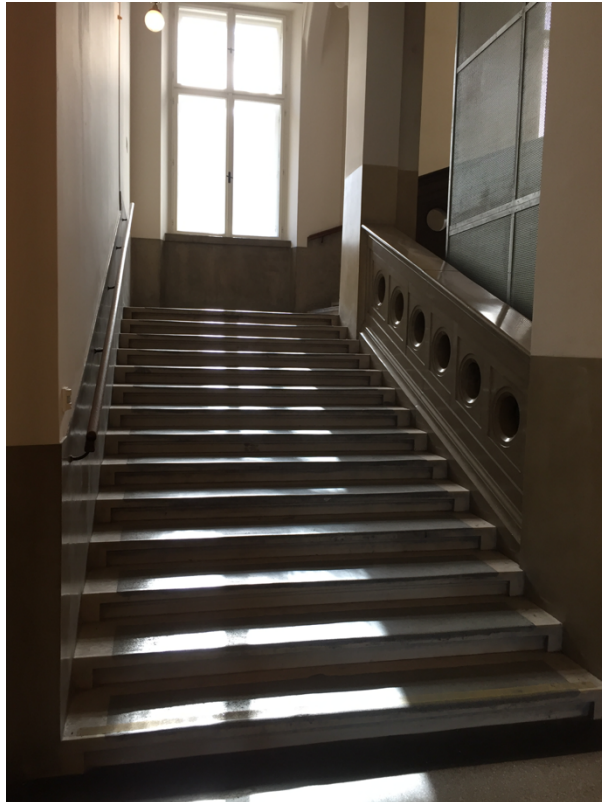
Figure 5-23 Main staircase 2 – S2

The second main staircase of the section (S2), grants access from the ground floor to the third floor. The staircase has a u-shape with double landings and a massive stone balustrade with original features. A handrail has been added along selected parts of the staircase. Optical marking stripes, on the first and last steps have been included, some of which have faded with time. A depiction of the second main stairs is presented in Figure 5-23.

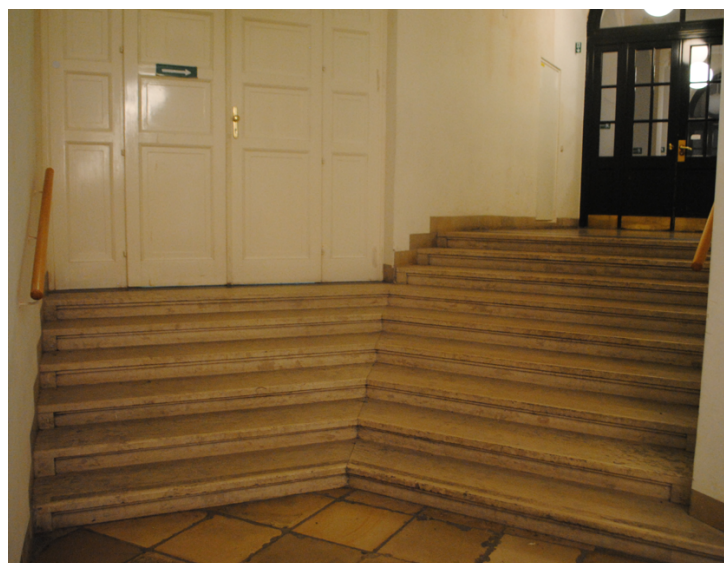
Figure 5-24 Stairs at the end of the eastern corridor - T10

Stairs consisting of nine steps (T10) are located in the eastern corridor to equalize the ground floor area between the first and second staircase of the AA section, as shown in Figure 5-24. A bifurcation in the stairs leads to a door at the end of the corridor. Handrails attached to the wall have been installed in different sections of each side of the stairs.

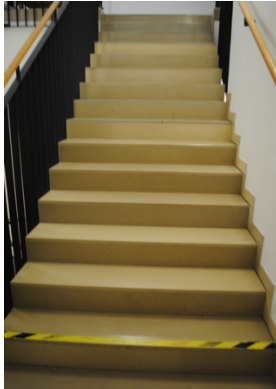
Figure 5-25 Auxiliary staircase leading to the top floor - S1a

Auxiliary staircases located on the third level grant access to the fourth and top floor. Staircase 1a (S1a) in the eastern corridor facilitates access to the dome auditorium and top eastern corridor. In the western corridor, staircases 1b (S1b) and 1c (S1c) lead to the dome from the west side and laboratories respectively. Figure 5-25, Figure 5-26 and Figure 5-27 show a section of each of the auxiliary staircases leading to the top floor.

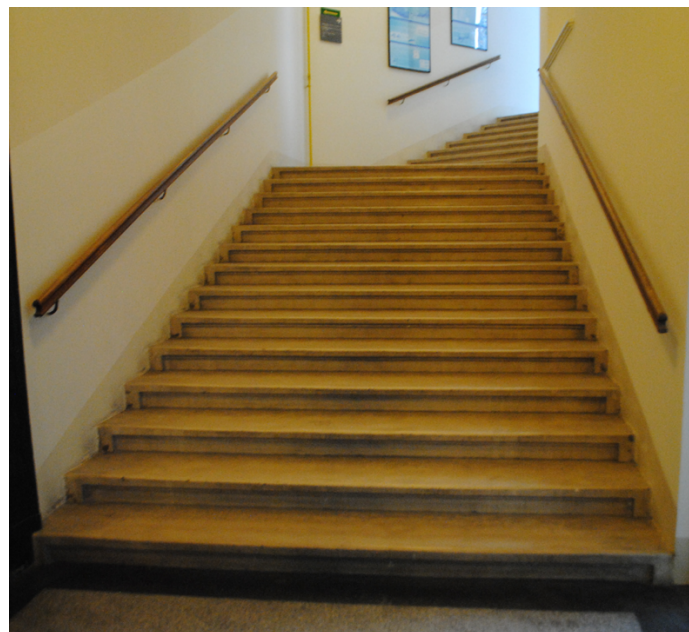
Figure 5-28 Stairs between the AA and AE tracts

Stairs of about twenty steps and one landing (T20, T21, T22, T23) equalize the level between the AA and the AE sections on all floors, from the ground level to the third level in the area of staircase 2. Wall mounted handrails have been installed in separate sections of the stairs, as shown in Figure 5-28.

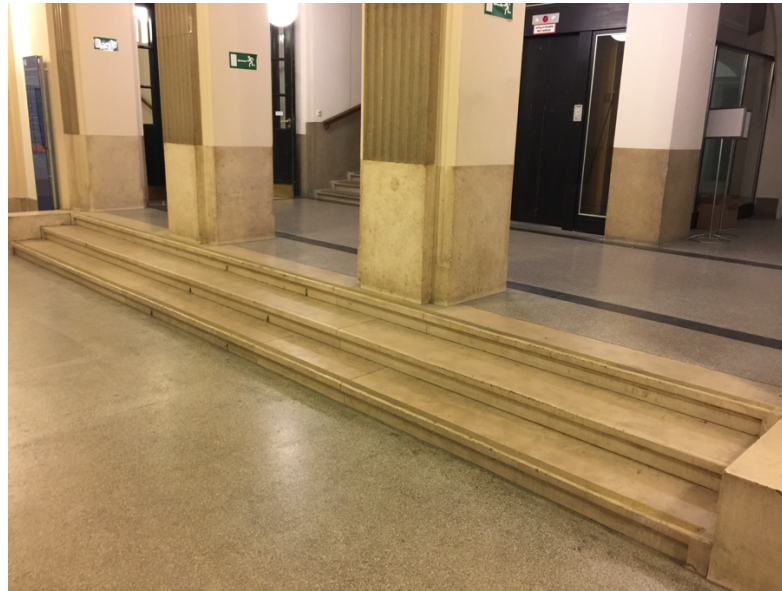
Figure 5-29 Flight of steps located on the ground floor – TE2

Located inside the second main entrance on the ground floor, is a flight of three steps (TE2) which must be used to reach the main stairs, the elevator and the corridors of the AE and AA sections. Handrails are not available across the whole width of these stairs. Figure 5-29 illustrates a detail of this configuration.

The lowest level of compliance (29%) is found in the same section by the area of the second staircase. The element TE2 is the result of its configuration: a flight of three steps positioned in a main hall that has not been adapted nor provided with a handrail, becoming a very critical barrier in the tract.

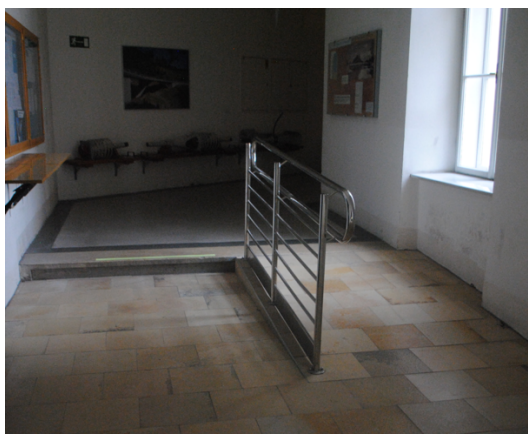
Figure 5-30 Step and ramp the end of the eastern corridor - R3S1

There are two ramps in the section of staircase 1. On the third floor, a 6% gradient ramp (R3S1) is used to compensate for a single step at the end of eastern corridor (see Figure 5-30). On the fourth-floor, a ramp with an inclination of 4% (R4S1) is used as a transition from the eastern corridor to sanitary facilities (see Figure 5-31).

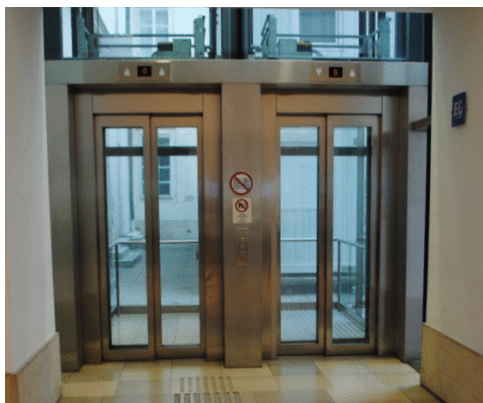
Figure 5-32 Elevator located in the area of the staircase 1 - L1

An elevator with two passenger cars and a capacity for thirteen people each, is located opposite the main staircase (L1). The elevator was built externally in 2009, and offers a view of the first courtyard through a glass structure. Figure 5-32 presents a frontal view of the elevator. Cars are accessible without steps on all floors and include automated doors, handrails, braille signalization, audio announcements, as well as reachable vertical and horizontal operating elements. Details of the operating elements are shown in Figure 5-33.

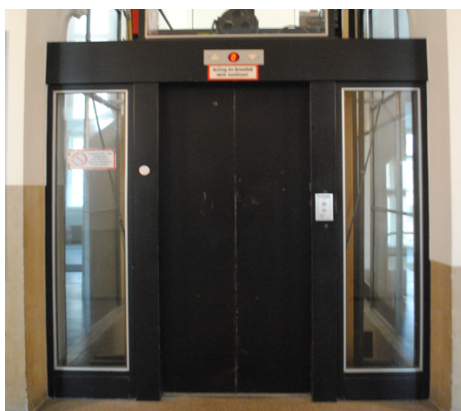
Figure 5-34 Elevator located in the area of the staircase 2 – L2a

An elevator with a capacity of twelve people was built in 1980 (L2a) in front of staircase 2, as shown in Figure 5-34. The car has sliding doors and a mirrorless wooden interior. The operating elements are not easily reached due to their height and shape. Embossed or braille signalization is not provided (see Figure 5-35). To access the elevator from the ground floor, several steps and stairs must be negotiated from every direction.

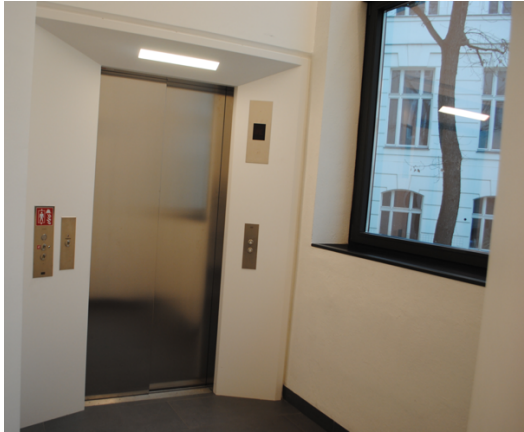
Figure 5-36 Elevator shared between AA and AE tracts– L2b

A second elevator (L2b) built in 2014 can be reached from all levels in the corridor leading to the AE section. Automated doors are located beyond the sanitary facilities and are especially installed for persons with disabilities. The elevator has double sided sliding doors and grants access to all floors of both sections AA and AE. The car includes a handrail, braille signalization, audio announcements and reachable vertical and horizontal operating elements. Figure 5-36 and Figure 5-37 present a view of the elevator and its operating elements respectively.

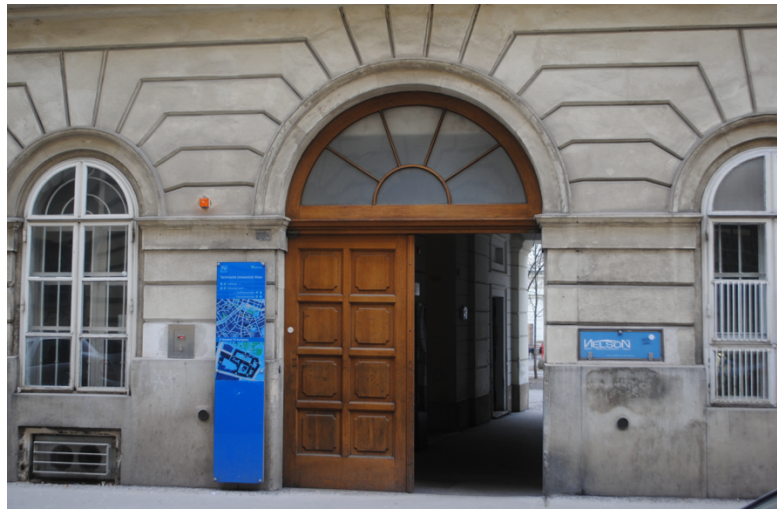
Figure 5-38 Main entrance on Paniglasse – EH2

The entrance to the building (EH2), consisting of massive wide wooden double doors with eight panels and an arched fanlight, is located on Paniglasse. The gates open to a gallery facing the second inner courtyard which is aligned in the same north-south axis as the main entrance of the building towards staircase 1. A view of the entrance from the street is given in Figure 5-38.

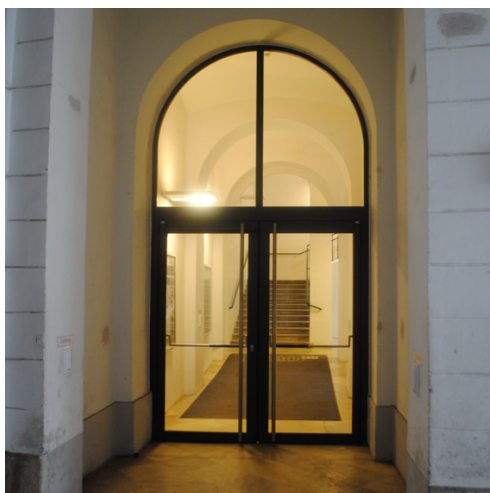
Figure 5-39 Entrance to staircase 6 – ES6

On the west side of the gallery, automated glass double swing doors with an arched fanlight have replaced the original entranceway (ES6), as can be seen in Figure 5-39. The new doors allow access from the second courtyard to staircase 6 through a transitional space in front of the stairway and through an elevator (see Figure 5-40).

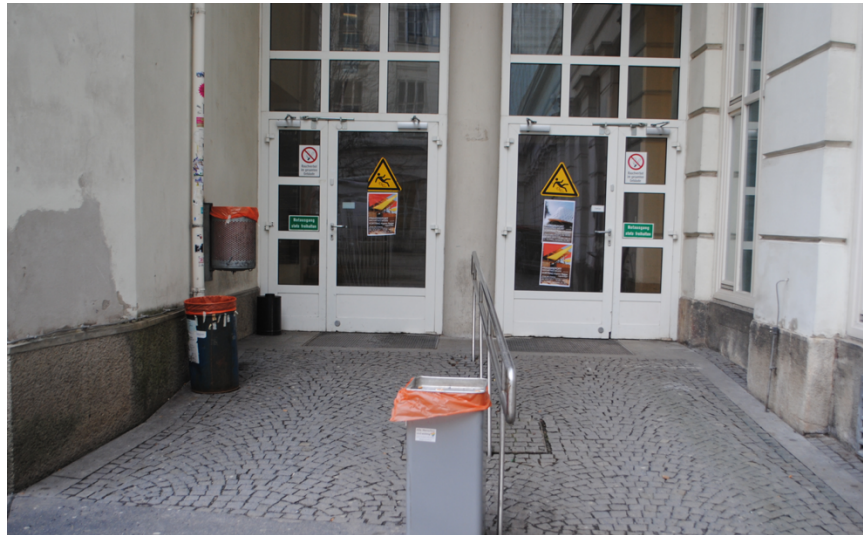
Figure 5-41 Entrance to staircase 7 – ES7

A ramp with uneven paving and two sets of glass doors provides access beyond the gallery to staircase 7 of the section (ES7). This leads to a transitional space with an elevator, offices, sanitary facilities and vending machines. Figure 5-41 and Figure 5-42 offer a view from the described entrance and the common areas.

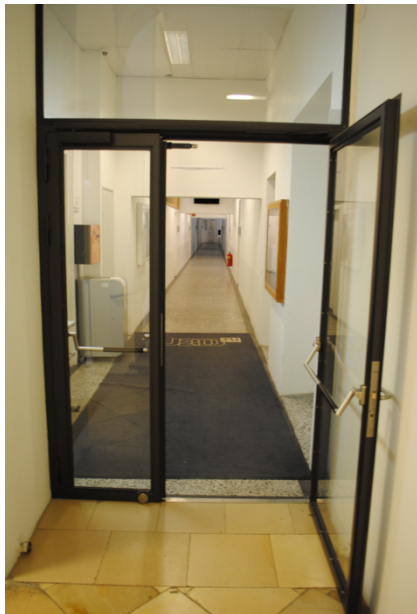
Figure 5-43 Corridor door on the first floor
- D1S6

on both the first and fourth floors. Figure 5-43 and Figure 5-44 show the doors on both the first and fourth level, respectively.

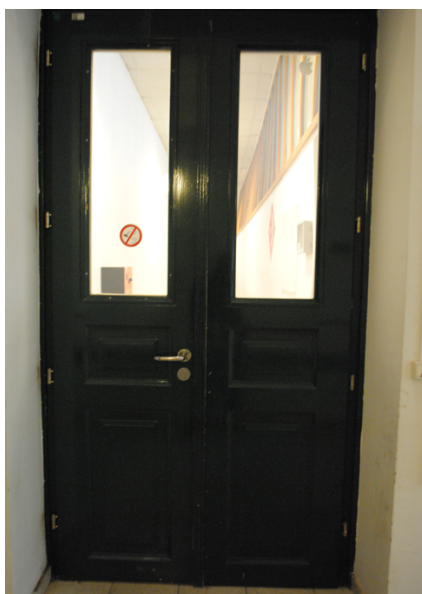
Figure 5-45 Corridor door on the first floor
- D1S7

On the east side, on the first floor, a wooden door with glass panels and narrow sections (D1S7) is situated in between the corridor and staircase 7 (see Figure 5-45). An elevator and a ramp are located near the door. On the fourth level, a glass double door with metal framing (D4S7) serves the same purpose as the door on the first floor, as can be seen in Figure 5-46.

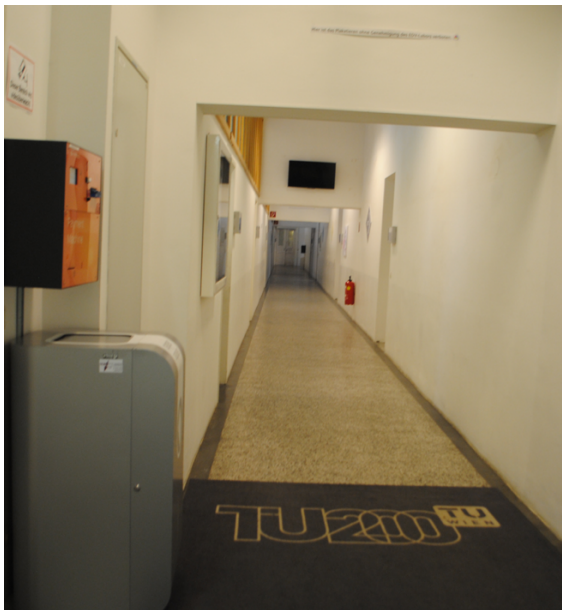
Figure 5-47 Corridor on the first level – C1S67

A corridor on the first and fourth floors connects both staircases 6 and 7. The corridor located on the first level (C1S67) allows access to offices, IT laboratories and architecture faculty training facilities (see Figure 5-47). Seminar rooms can be accessed from the corridor on the fourth floor (C4S67) (see Figure 5-48).

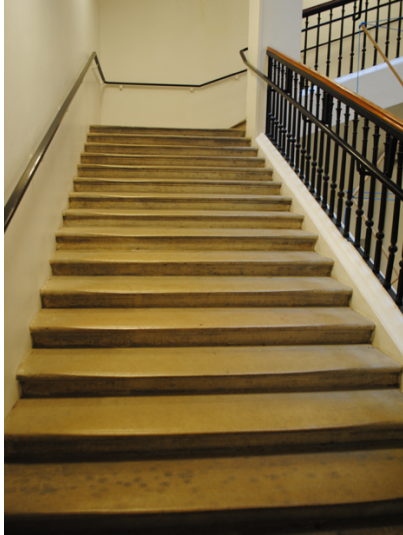
Figure 5-49 Main staircase 6 – S6

Staircase 6 (S6) is a principal staircase with double landings, providing access from the ground level to the fourth floor. Four columns with decorative vases on the third level support the u-shaped stone structure, which features continuous handrails on both sides of the wall and on the columns, parallel to a metal balustrade. In addition to providing access to the AF section, this staircase enables to reach the AG tract from the south. Figure 5-49 and Figure 5-50 present different views of staircase 6.

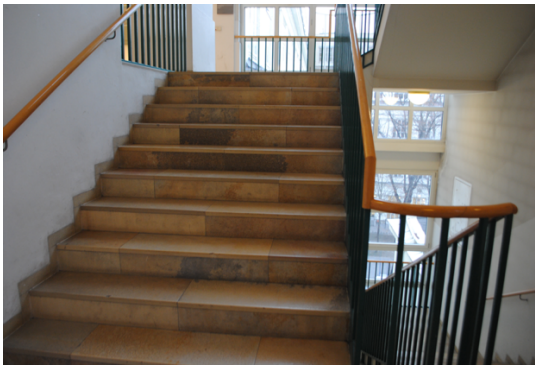
Figure 5-51 Main staircase 7 – S7

Staircase 7 (S7) provides access from the ground level to the fourth floor. It features a metallic balustrade topped by a wooden handrail. There are semi-circular half landings at each level on its eastern side and two quarter straight landings on its western side. On the fourth floor, the steps begin to curve. Figure 5-51 and Figure 5-52 show two different views of the staircase. Sections AE and AH are accessible from this structure.

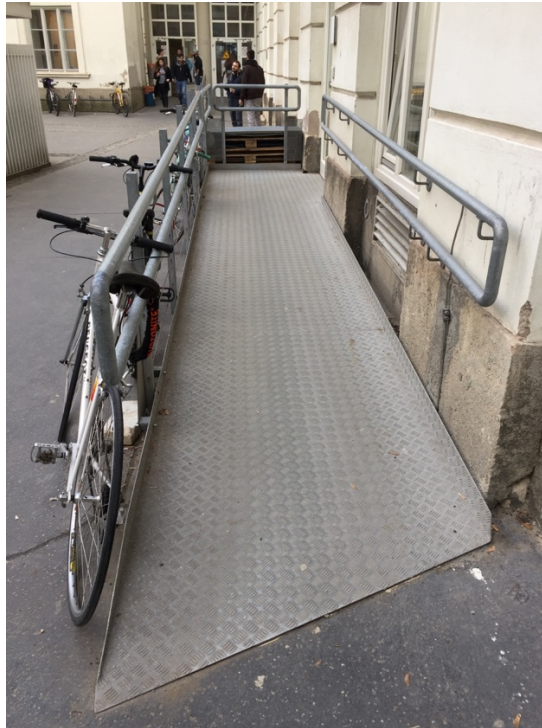
Figure 5-53 Ramp in the second inner courtyard – RH2

An L-shaped, 5% incline semi-permanent aluminium ramp (RH2) from the second inner courtyard allows access to the laboratories located on the ground floor, as shown in Figure 5-53.

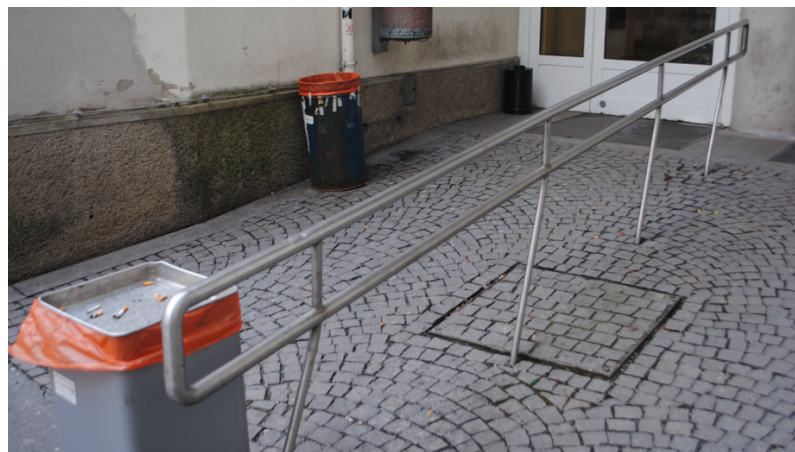
Figure 5-54 Ramp by the entrance of staircase 7– R0S7

A ramp (R0S7) with irregular pebble flooring and an inclination of 7,5% from the same courtyard, is located at the entrance to staircase 7 with a double handrail in the center (see Figure 5-54).

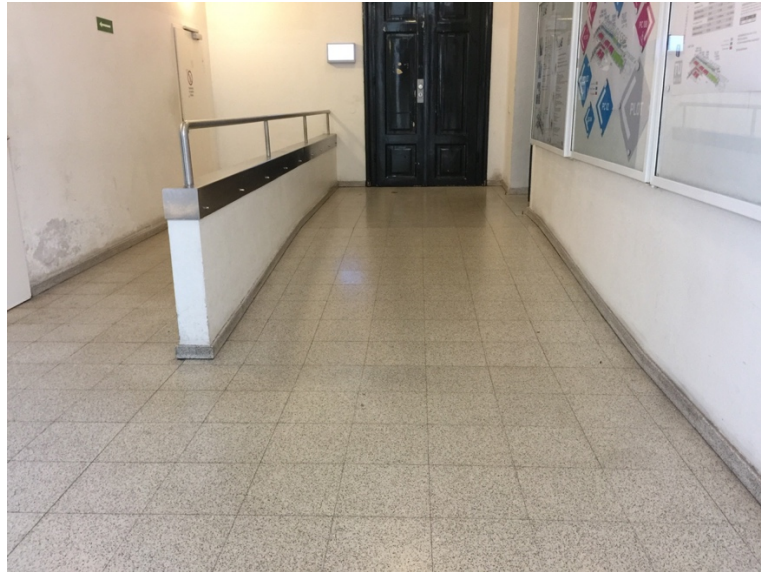
Figure 5-55 Ramp in the faculty of architecture – R1S7

On the first floor of staircase 7, a ramp (R1S7) leads to the corridor that transitions towards staircase 6 through the architecture faculty laboratories. This element separates the entrance of the corridor and an office door from the elevator, sanitary facilities and staircase (see Figure 5-55).

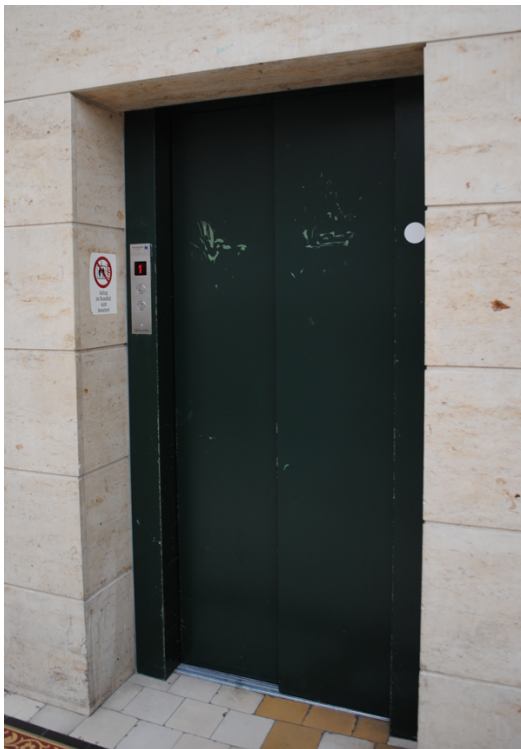
Figure 5-56 Elevator located in the area of staircase 6 – L6

An elevator (L6) was built in 1985 near staircase 6 (see Figure 5-56). The 8-people capacity car has sliding doors and a mirrorless interior. Levels are not verbally announced. The embossed operating elements are not easily reached due to their height, and do not provide braille signalization, as can be seen in Figure 5-57.

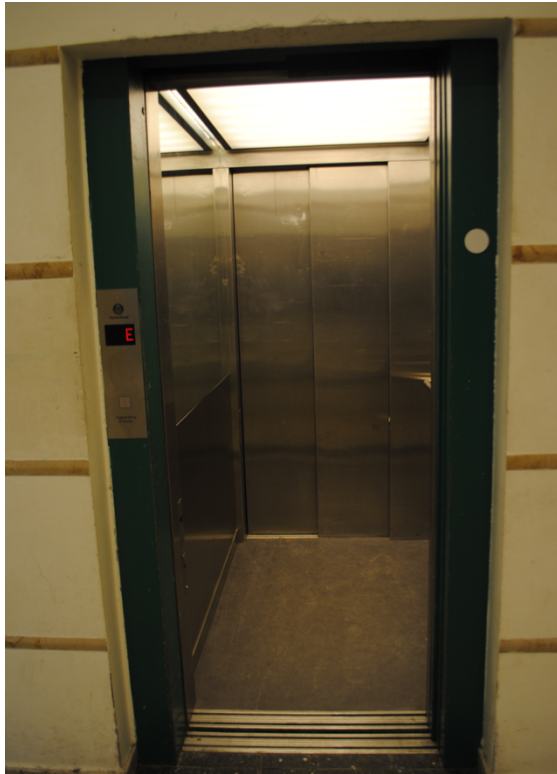
Figure 5-58 Elevator located in the area of staircase 7 – L7

On the opposite side, next to staircase 7, an elevator (L7) with automated double sliding doors grants access to all floors of sections AF and AE. The elevator was built in 1988 and is equipped with a mirror and handrail. Its operating elements are embossed, as in the elevator L6, but do not provide braille signalization. There are no voice announcements of levels to aid people who are visually impaired. Figure 5-58 and Figure 5-59 show a view of the car and its operating elements respectively.

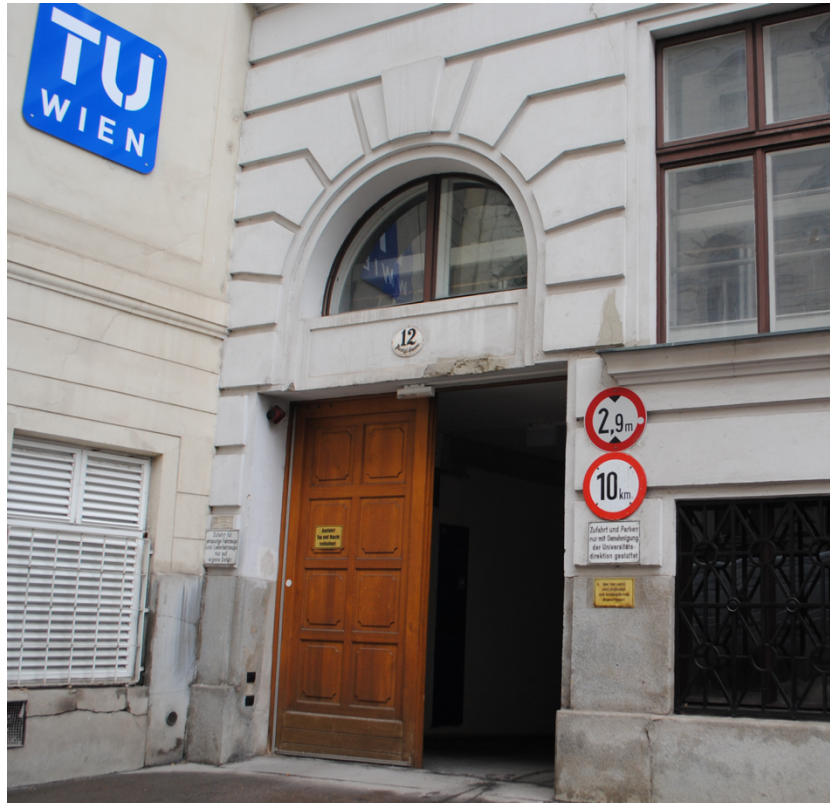
Figure 5-60 Informal entrance through garage - EH4

On the eastern side of the Paniglgasse 12, there is an informal entrance (EH4), used mainly for garage access (see Figure 5-60). The gates open to a ramp with an incline towards the fourth and third courtyards, from where an inner entrance grants barrier free access to the AE tract.

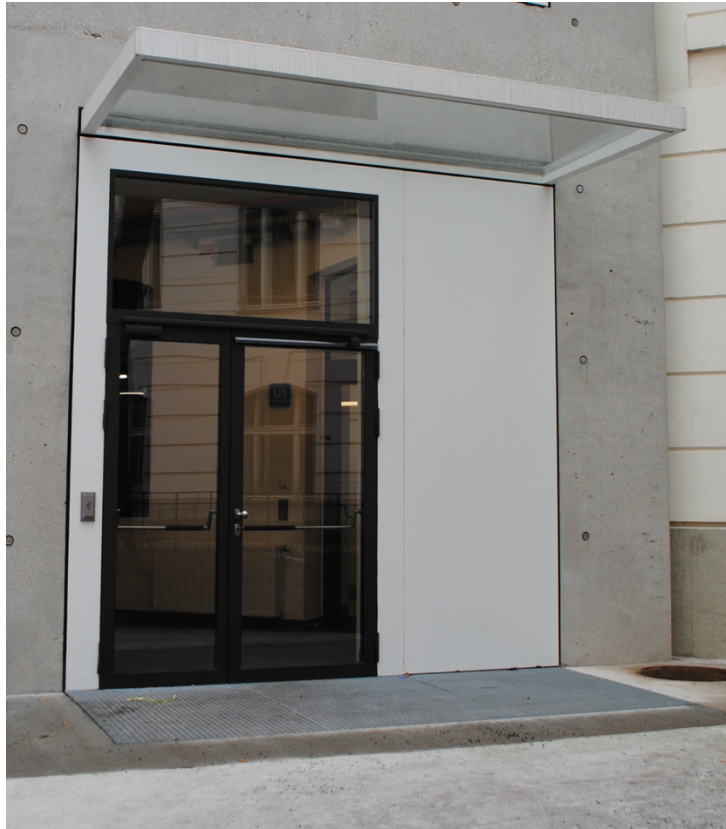
Figure 5-61 Entrance from the third inner courtyard to the AE tract – EH3b

The entrance on the third inner courtyard (EH3b) allows barrier free admission through automated double glass doors to elevator L2a. This elevator, as previously described, allows access to all the floors of the AE section and is shared with the AA section.

The third inner courtyard can be reached from the first, second and fourth courtyards using the previously described entrances: ES1 and EH1, EH2 or EH4 respectively. Access is provided through the corridors and galleries located on the ground floor of the AB, AH and AE sections. There are no signs indicating this barrier free entrance, which complicates the path finding. A view from the entrance of the third inner courtyard is presented in Figure 5-61.

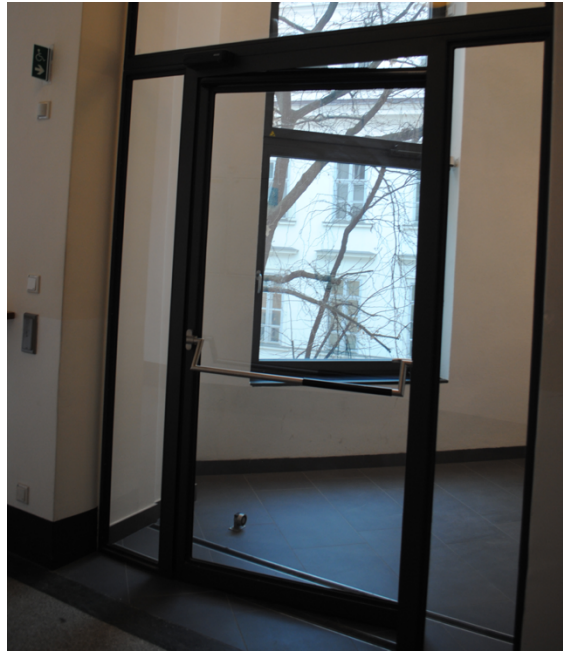
Figure 5-62 Automated doors in the corridors of the AE tract

Automated glass swing doors grant access from elevator L2a to the main corridors on all floors of the AE section (D0S8a, D1S8a, D2S8a, D3S8a). These entries are located on the northern points of the corridors, where there is a transition area to the AA section towards staircase 2. Figure 5-62 shows a sample of the entries located on all floors.

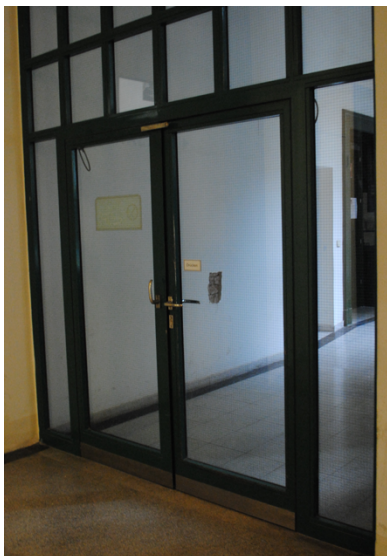
Figure 5-63 Glass doors at the end of the corridor in the ground level – D0S8b

Metal-framed glass doors are located at the southern point of the section's corridors. On the first level, these doors (D0S8b) are positioned before the separation of the section to the west, and allow access with two ramps to staircase 7, elevator L7 and an auditorium through an extension of the main corridor (see Figure 5-63). From the first to the third levels, these doors (D1S8b, D2S8b, D3S8b) are located beyond the intersection leading towards the west. On the second and third floors, the doors offer direct access to staircase 7, elevator 7 and an auditorium. Figure 5-64 presents a sample of the doors at the end of the corridor on the upper levels.

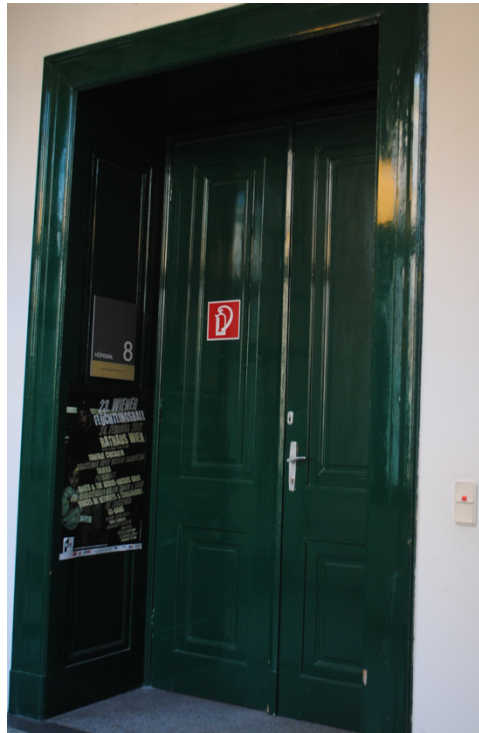
Figure 5-65 Doors providing access to elevator L7 in the first floor – D1S8e

On the first floor, an additional set of wooden double doors with narrow leaves and high operating elements (D1S8e) is placed between the door at the end of the main corridor and the transitional space that allows passage to the auditorium and elevator (see Figure 5-65).

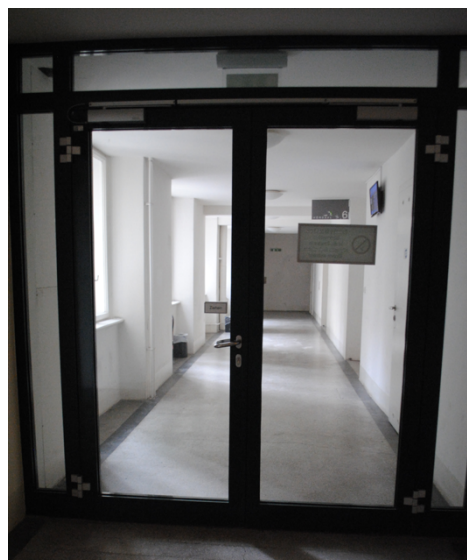
Figure 5-66 Doors towards the orthogonal corridor leading to tract AH

A metal framed glass door (D0S8c) leads to an orthogonal corridor in the middle of the section. This corridor is only accessible from the main corridor of the ground floor, as shown in Figure 5-66.

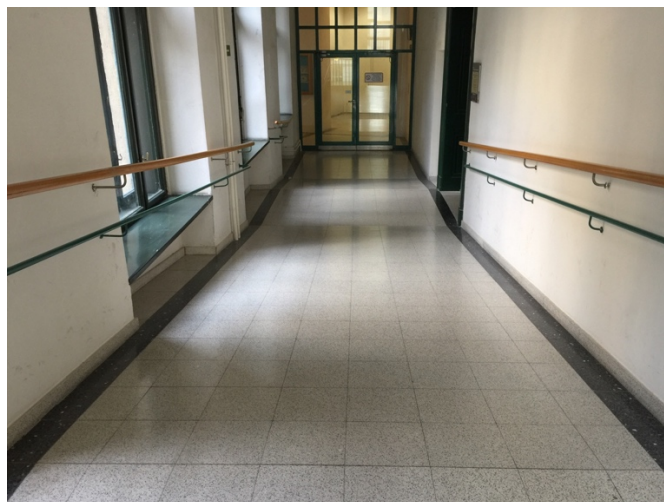
Figure 5-68 Corridor division in the ground floor of the AE Tract – C0S8b

A door on the ground floor divides the corridor into another corridor section near the intersection of the west leading corridor (C0S8b), where two ramps are located (see Figure 5-68).
