A Systematic Evaluation of Barrier Free Adaptations in Historic Buildings - The Case of the Main Building at the TU Wien

A Master's Thesis submitted for the degree of
"Master of Science"

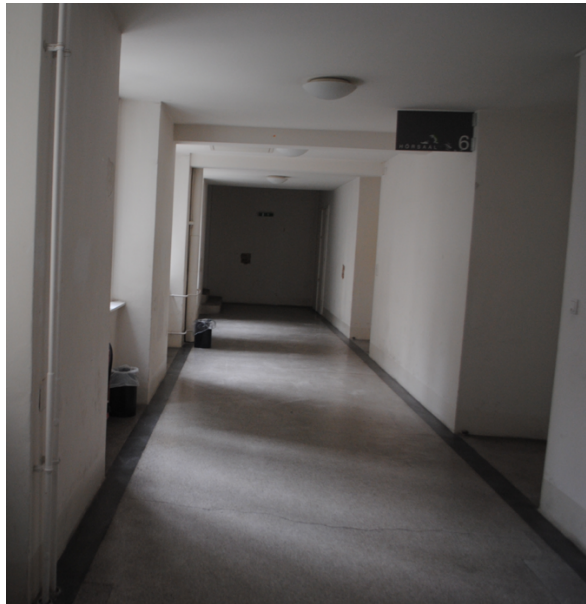
Figure 5-69 Orthogonal corridor in the AE Tract – C0S8a

On the ground floor of the central area corridor, a cross section of the structure can be entered through another corridor (C0S8a). This passage connects to an auditorium in the AH section of the building, as can be seen in Figure 5-69.

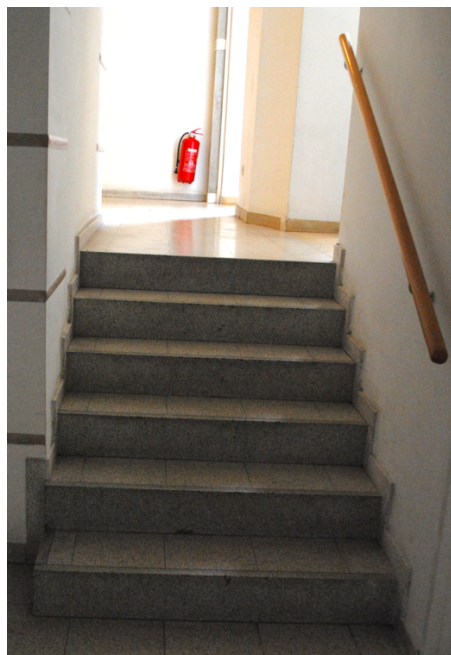
Figure 5-70 Stairs at the end of main corridor between sections AE and AF – T80b

Six steps (T80b) on the ground floor at the end of the corridor next to elevator L7 compensate for the level variations from the AE to the AF sections (see Figure 5-70). High handrails have been mounted on one side of the wall.

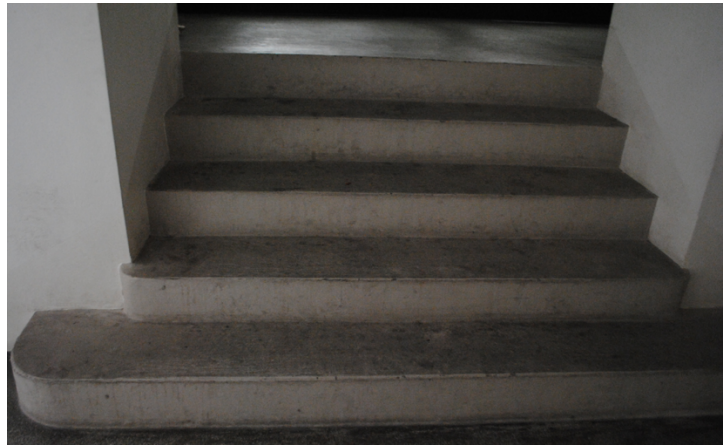
Figure 5-71 Stairs at the end of orthogonal corridor between tracts AE and AH – T80a

Five-step stairs (T80a) located in the intersecting corridor of the ground floor serve as the transition from the AE to the AH tracts. No handrails or optical markings have been provided. Figure 5-71 shows a view of the stairs.

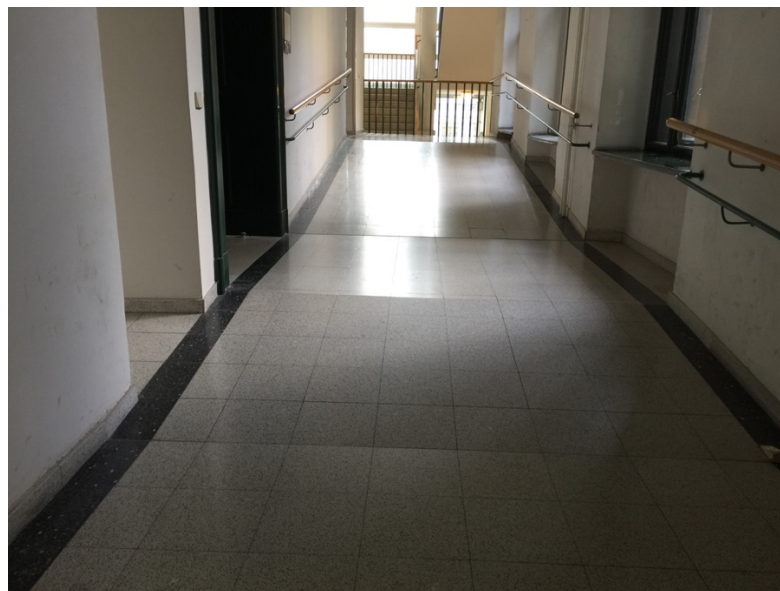
Figure 5-72 Ramps at the end of the corridor of the ground floor.

This ground floor section features two consecutive ramps with a gradient of 12% and 13% (R0S8a, R0S8b). The ramps level the corridor located in the AE section with the corridor in the AF section, and the area leading to elevator L7 (see Figure 5-72).

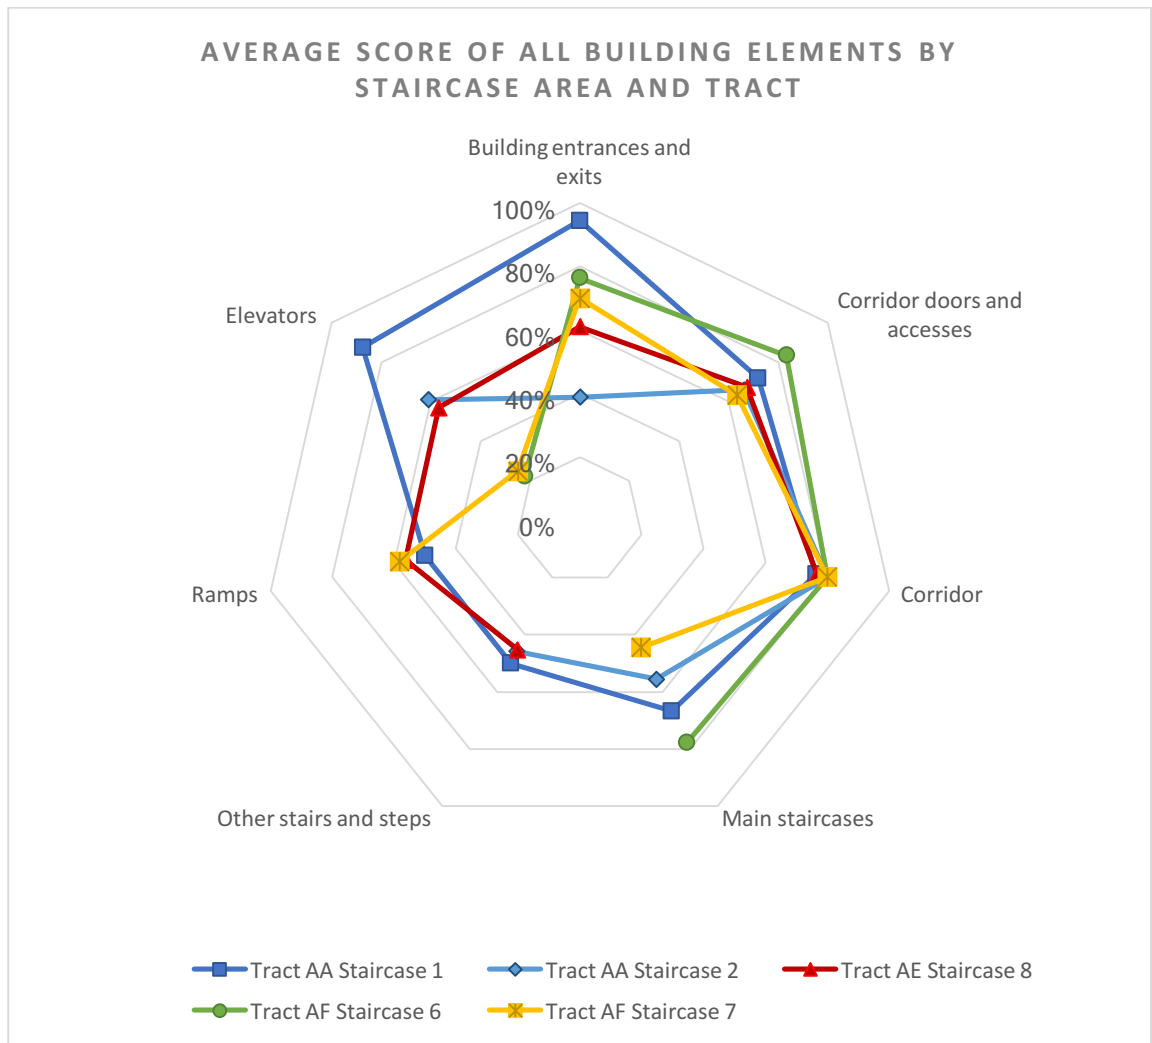
Figure 5-74 Overall average score of all building elements under study by staircase area and tract

This chart shows that in all staircase areas the categories that exhibit similar characteristics and scoring are corridors, ramps, other stairs and steps and corridor doors and accesses. The biggest differences encountered for the compliance with barrier free requirements can be observed in the elevators category, with the elevators by staircase 1 being superior in providing accessibility than the rest. Elevators in staircase 7 and 6 are at the bottom of the list, whereas the ones granting access to staircase 2 and 8 present an overall average scoring. The category building entrances and exits also shows considerable differences in compliance amongst the staircase areas with the most critical zone of this category located in staircase 2. The entrances by staircase 1 on the other hand provide an example of best practices in complying with accessibility requirements. From the main staircases analyzed, the scoring received from highest to lowest was given to staircases 6, 1, 2 and 7. A comprehensive assessment of each category under study is presented below.

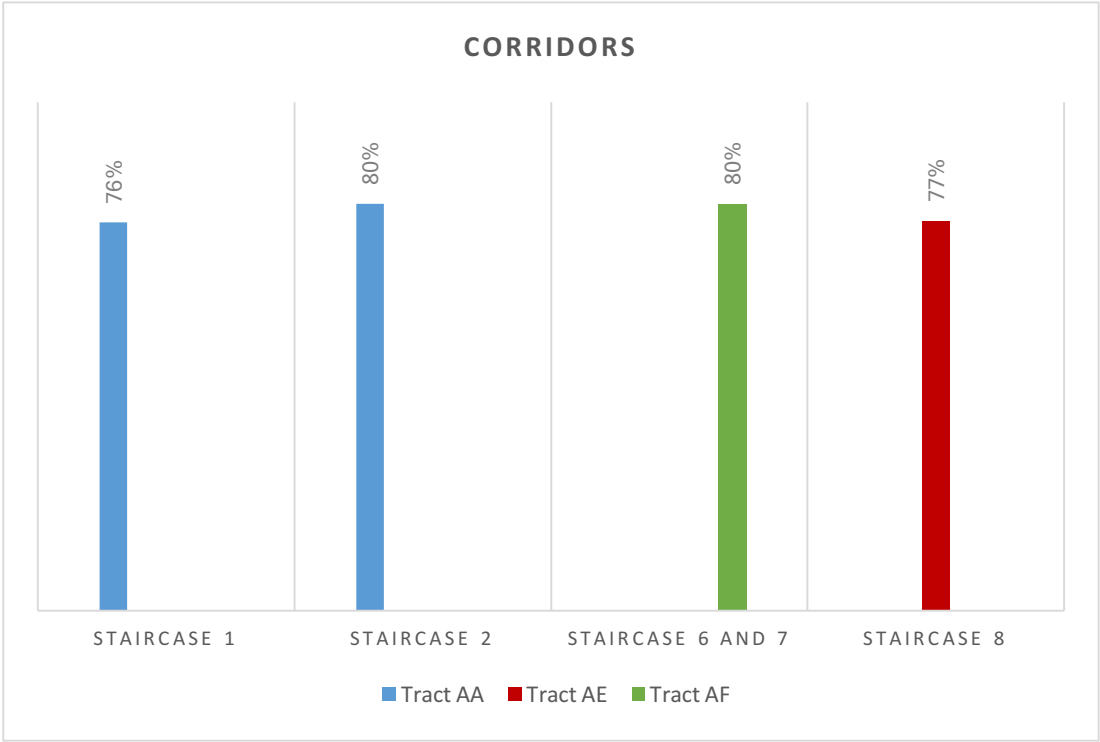
Figure 5-77 Average compliance of corridors by staircase and tract

Figure 5-77 shows the average compliance of all corridors by tract and by staircase area. It can be noted from this chart, that the corridors from the area of the first staircase of the AA tract present the most barriers with an average compliance of 76%. These are followed by the corridors located in the AE section with a score of 77%.

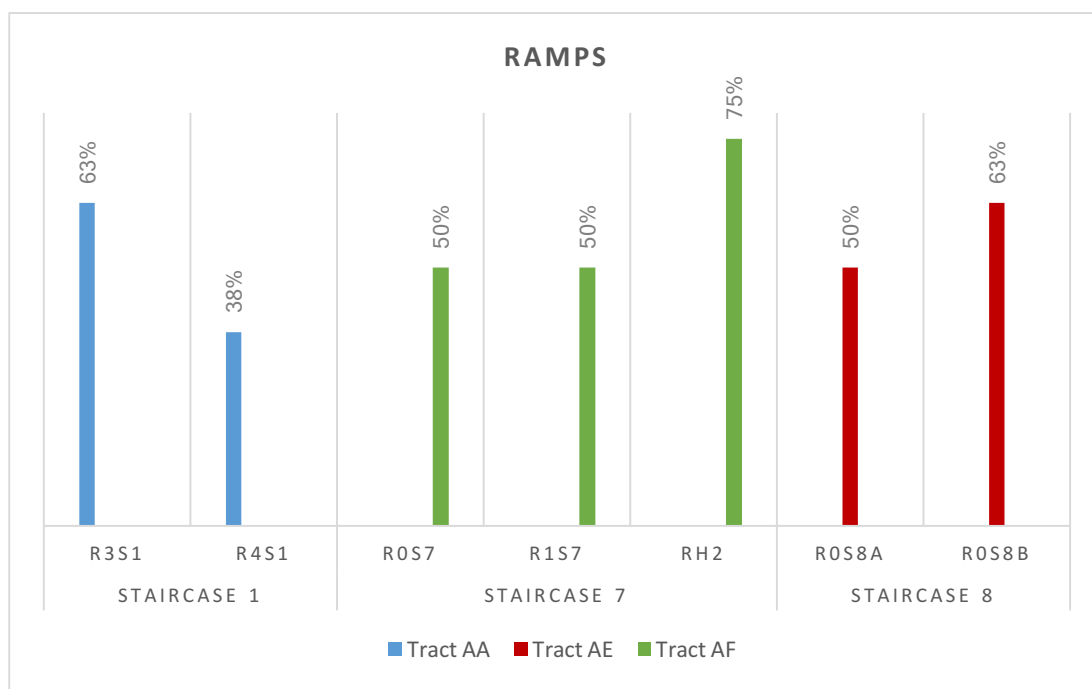
Figure 5-80 Compliance of ramps by staircase area and by tract

The matrix developed for the ramp category is presented in Table 5-6. The results of this checklist show that all ramps evaluated fulfil the accessibility width requirement. Six out of seven ramps comply with the dimensions of the movement area and the provision of a proper handrail profile, and five out of seven satisfy the barrier free conditions of gradient and handrail height. None of the ramps provide optical markings and wheel deflectors and only two out of seven present a handrail on both of sides.

In the AA section of the first staircase area, a ramp located in the eastern corridor of the third level to compensate for a single step (R3S1) has a compliance of 63%. The ramp with the lowest score (38%) can be found on the way to sanitary facilities (R4S1) on the fourth level of the same tract. This ramp has not been provided with the minimal gradient required for handrails, estimated at 4%.
